Horror stories from the air conditioning vaults

With a team of inspectors currently visiting hundreds of firms across the south, energyTeam has a unique perspective on the common mistakes and omissions that are compromising air conditioning efficiency and costing British business dearly, according to **Brian Rickerby**

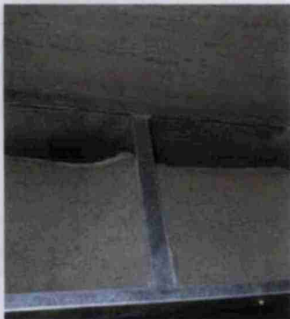
Blocked filters

This ducted fan coil filter was so blocked with dust that it is being sucked back into the fan motor. This prevented the return air from the room being conditioned effectively so the unit had to work harder to reach its target temperature. In addition, the fan motor would have consumed more power due to the resistance caused by the blocked filter, resulting in premature failure of the fan motor.

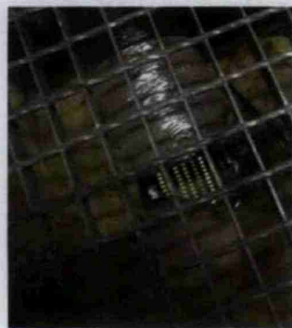
Air leakage

The ducting in the ceiling void has been torn away from the supply grille, subsequently expensive conditioned air was being lost into the roof space instead of serving the the room below.

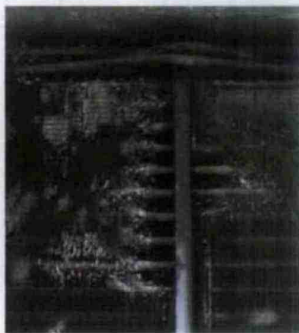
Refrigerant leakage

These oily stains could be the sign of a refrigerant leak. It is illegal to knowingly allow refrigerant to escape into the atmosphere and leaks should be repaired by a

qualified engineer. F-gas refrigerant systems such as R22 should have their refrigerant quantities recorded as well as any leak repairs for systems over 3kg of refrigerant. All details should be retained in the building log book.
